RE: Powder Springs Road Plating
Austell, Cobb County, Georgia
Preliminary Assessment Report

**PRELIMINARY ASSESSMENT
POWDER SPRINGS ROAD PLATING
AUSTELL, COBB COUNTY, GEORGIA**

June 2019

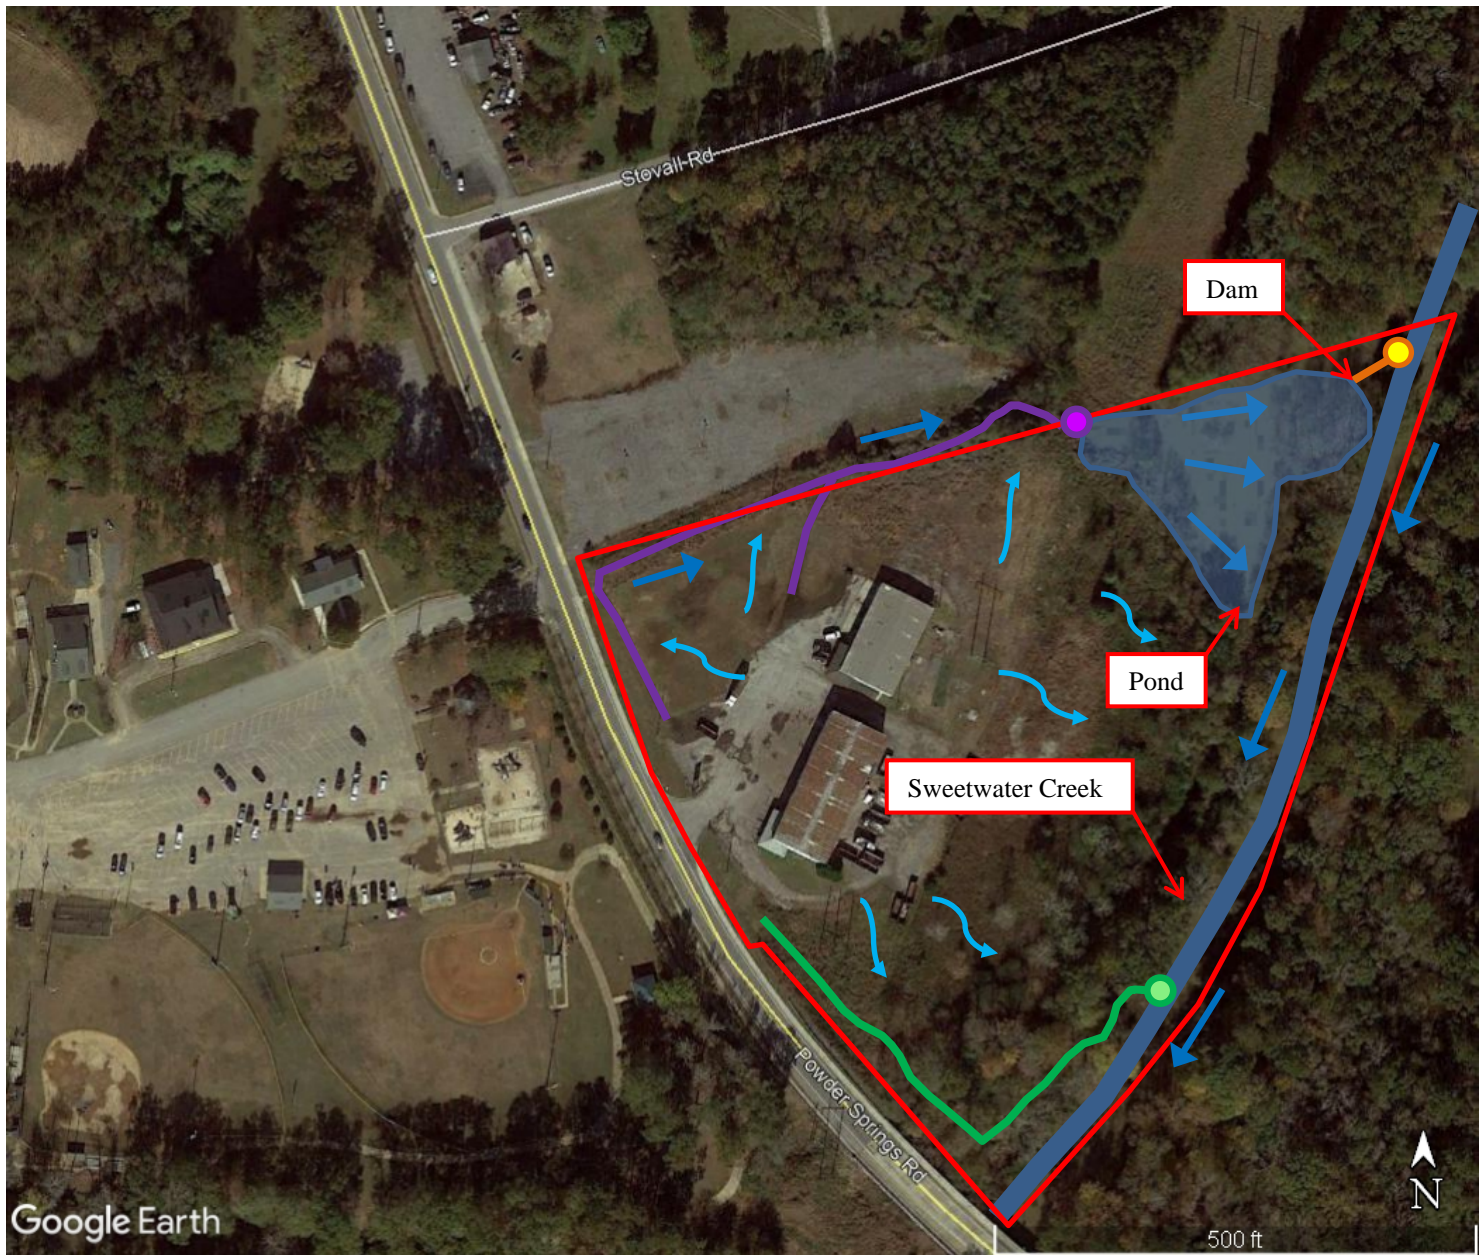
**FIGURE 1: Water Features and Site Generated Run-Off
Routes Observed During the GEPD May 14, 2019
Site Reconnaissance**

1. — = Approximate site boundaries.
2. — = Site Generated Run-off Drainage Route #1.
3. — = Site Generated Run-off Drainage Route #2.
4. — = Site Generated Run-off Drainage Route #3.
5. ● = Approximate discharge from Drainage Route #1 to on-site pond.
6. ● = Approximate discharge from Drainage Route #2 to Sweetwater Creek.
7. ● = Approximate discharge from Drainage Route #3 to Sweetwater Creek.
8. → = Surface water flow direction.
9. → = Site generated run-off water flow direction.
10. GEPD = Georgia Environmental Protection Division

- Well-defined drainage ditches were observed to the northwest of Building A, along the northwestern and northern boundaries of the site, just east of Austell Powder Springs Road (See Attachment A: Photographs 05, 06 & 16 of 26). The ditch along the northwestern boundary slopes towards the north and intersects with the ditch along the northern boundary, which slopes towards the east/northeast and ultimately discharges to an approximate 1-acre on-site pond (hereinafter referred to as “Discharge Point A” located on the northeast portion of the site (See Attachment A: Photographs 16 & 17 of 26). A drainage ditch was observed extending from the northeastern-most paved area to the ditch running along the northern boundary of the site (See Attachment A: Photograph 15 of 26). No water was observed within the drainage ditches at the time of the site reconnaissance. Site-generated run-off from areas north and northwest of the metal buildings would flow through the ditches and ultimately discharge to the pond (See Attachment B: Figure 1);

- A well-defined drainage ditch was observed to the southwest of Building A along the western boundary of the site, just east of Austell Powder Springs Road. The ditch along the southwestern boundary slopes towards Sweetwater Creek to the south/southeast, meanders towards the northeast through low-lying areas paralleling Sweetwater Creek and ultimately discharges to Sweetwater Creek at a point approximately 300 feet north (downstream) of the Austell Powder Springs Road bridge (See Attachment A: Photographs 21 & 22 of 26 and Attachment B: Figure 1); and

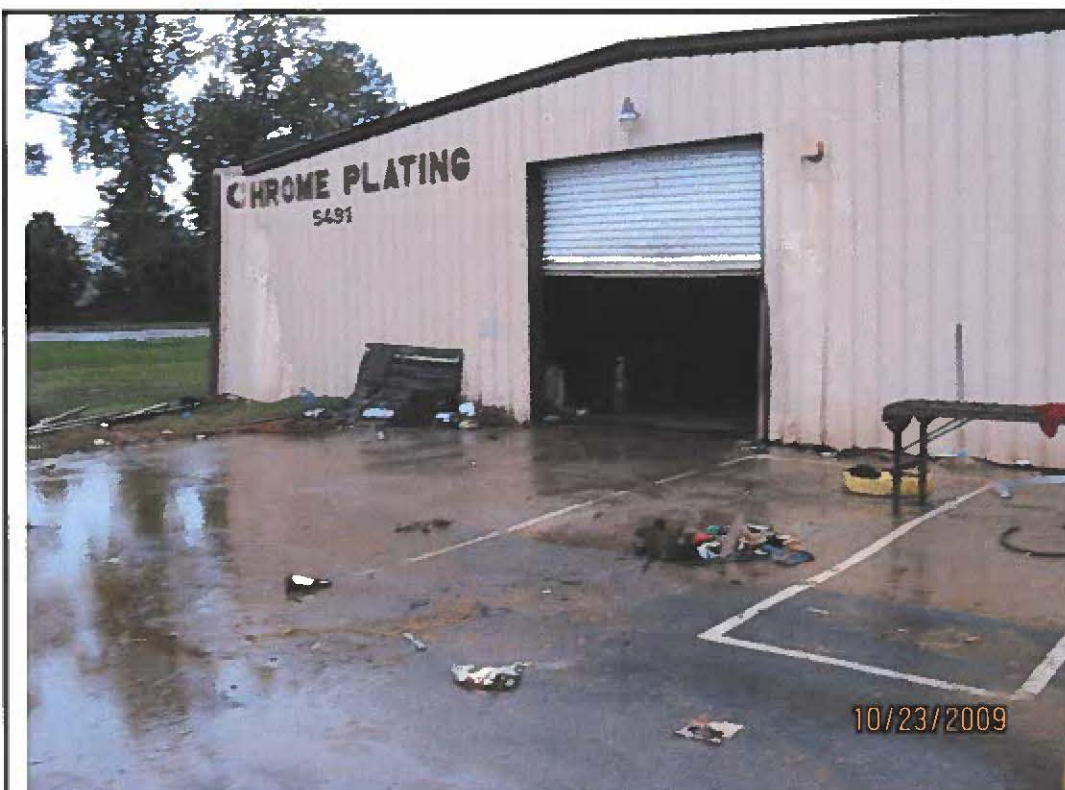
Explanation: Entrance to facility. Note security fence to left of building is down.
--

- Damaged fencing circumscribing portions of the site was observed and access to the site was unrestricted;
- Discolored dark brown to black liquid and sludge mixed with soil was observed on the floor of the electroplating building. The dark liquid was observed emanating from the plating tank area (near the west side of the building) and from an unknown number of overturned 55-gallons drums of unknown contents (in the northern portion of the building);

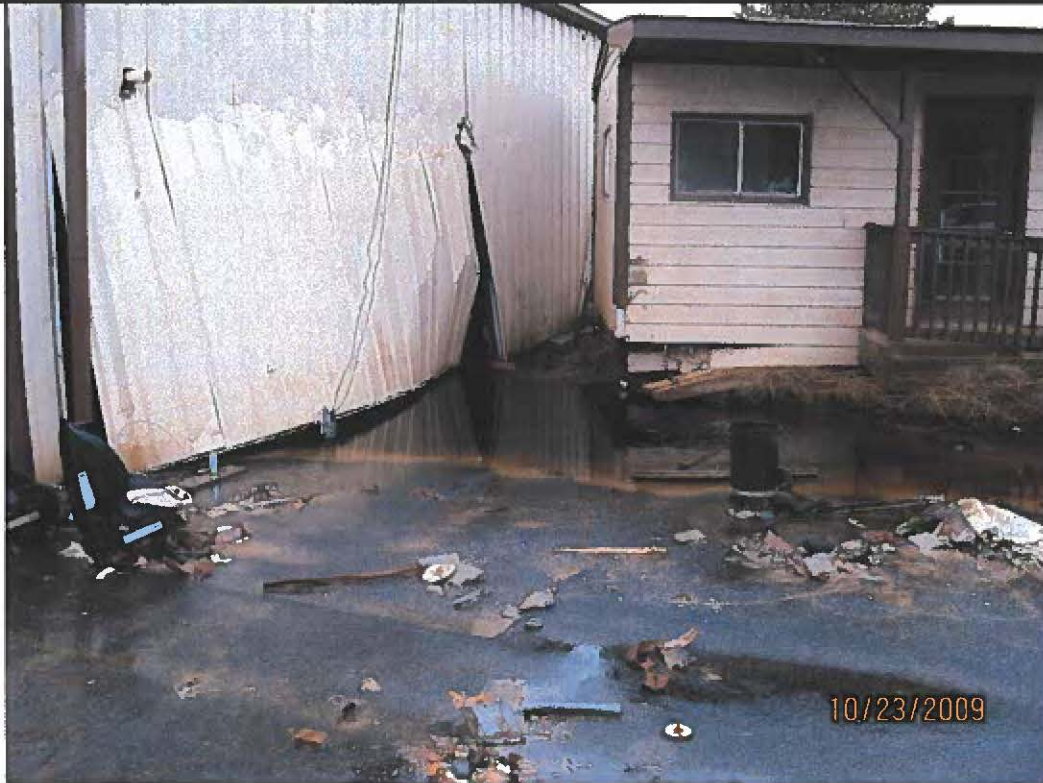
Facility Name: HW Enterprise Inc./Peach Chrome Plating	Location: Austell
Photo #: 3	Photographer: R. Hardy
Date: 10/23/2009	
Explanation: Release onto asphalt apron.

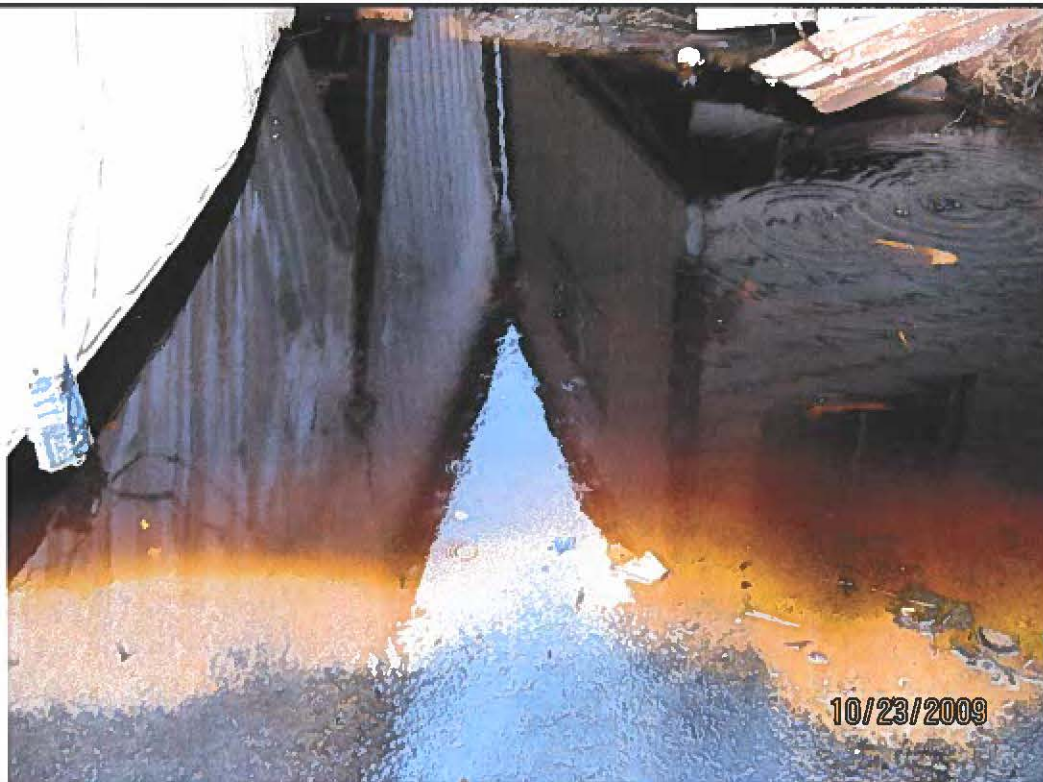
Facility Name: HW Enterprise Inc./Peach Chrome Plating	Location: Austell
Photo #: 4	Photographer: R. Hardy
Date: 10/23/2009	
Explanation: Close up of release pool.

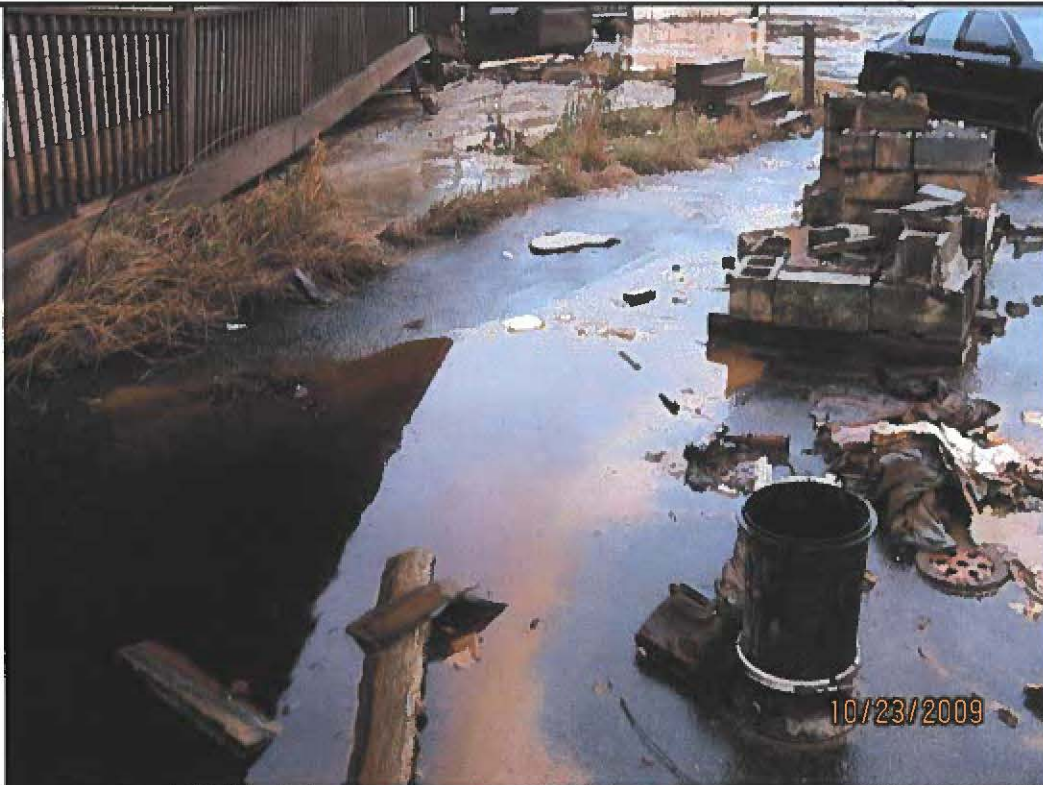
Facility Name: HW Enterprise Inc./Peach Chrome Plating	Location: Austell
Photo #: 5	Photographer: R. Hardy
Date: 10/23/2009	
Explanation: Tracking the release down gradient.

- Discolored runoff from the pool was observed running atop the asphalt for over 100 yards towards the north and east, ultimately discharging to Sweetwater Creek;

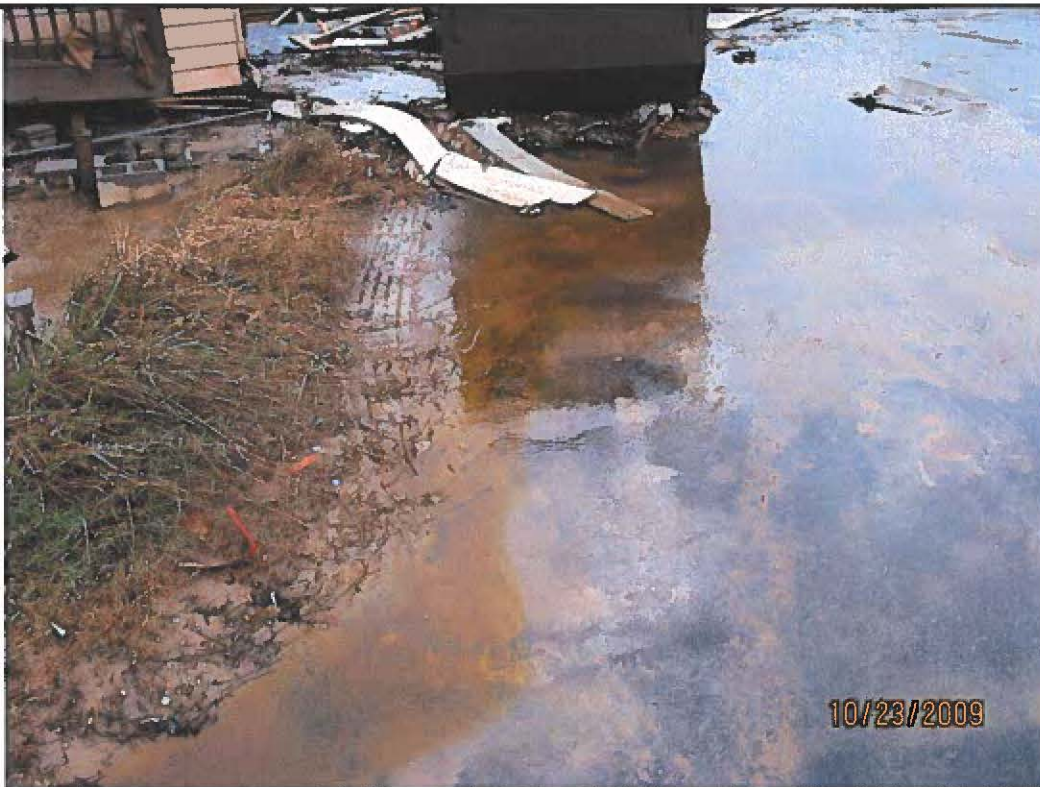
Facility Name: HW Enterprise Inc./Peach Chrome Plating	Location: Austell
Photo #: 7	Photographer: R. Hardy
Date: 10/23/2009	
Explanation: Tracking the release down gradient

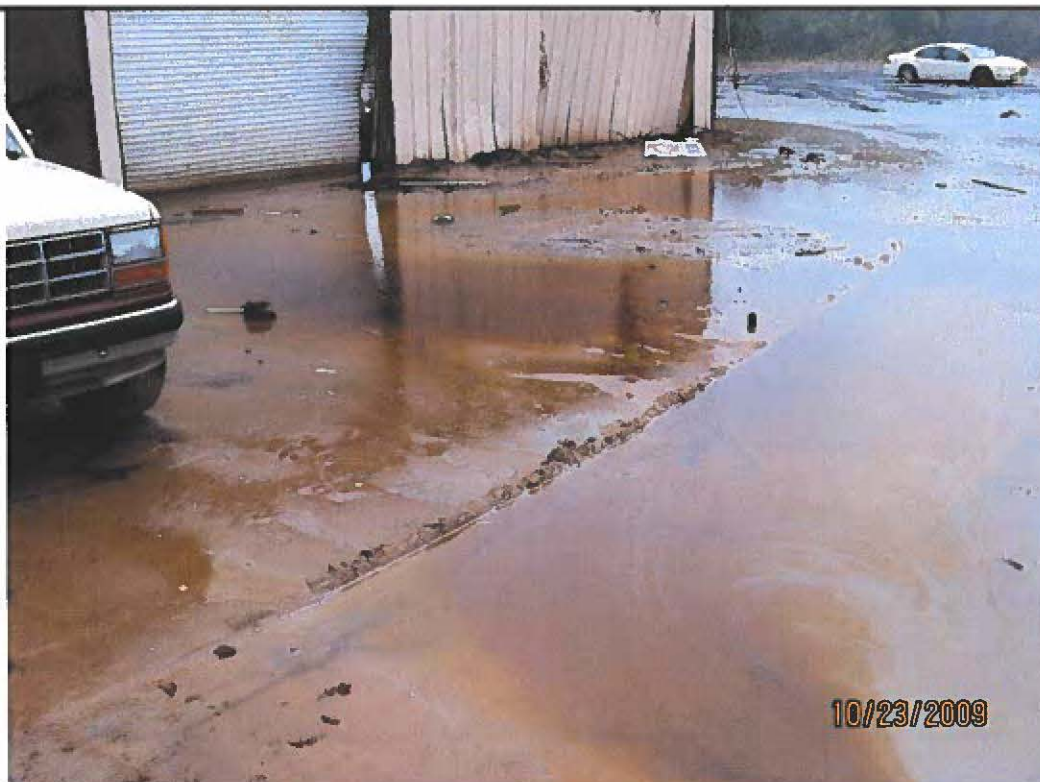
Facility Name: HW Enterprise Inc./Peach Chrome Plating	Location: Austell
Photo #: 8	Photographer: R. Hardy
Date: 10/23/2009	
Explanation: Tracking the release to down gradient business. Note discolored puddles

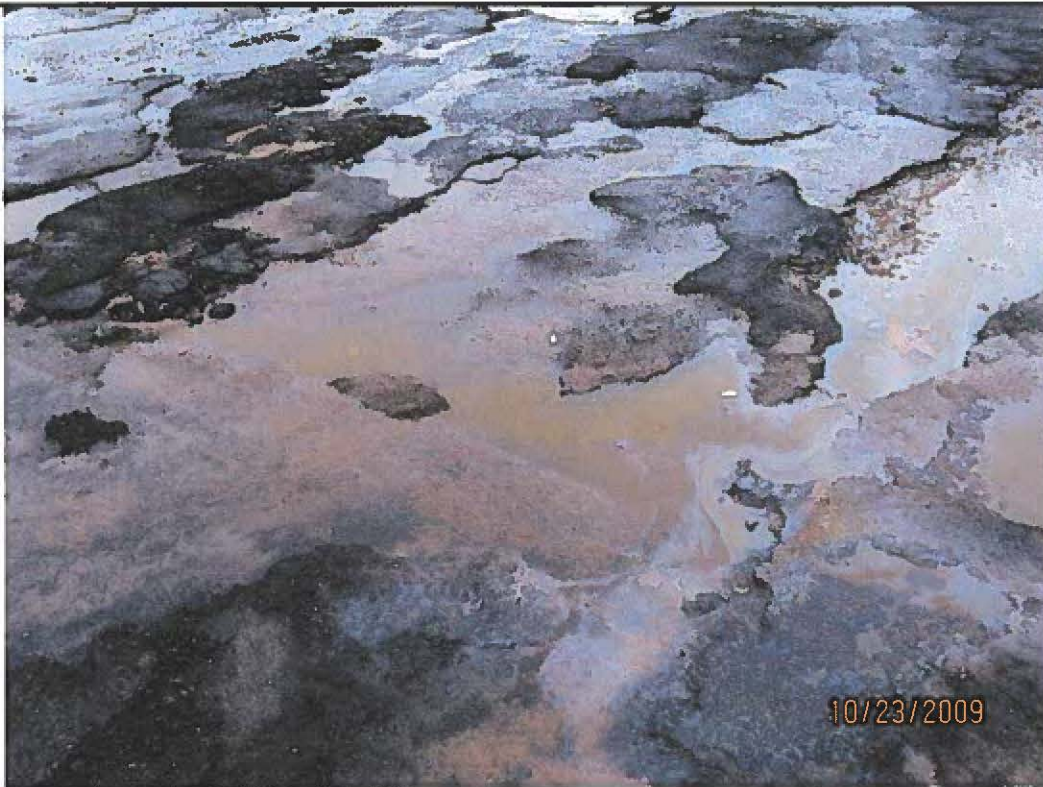
Facility Name: HW Enterprise Inc./Peach Chrome Plating	Location: Austell
Photo #: 9	Photographer: R. Hardy
Date: 10/23/2009	
Explanation: Tracking the release down gradient. Note cracks and breaks in asphalt

- Intermittent portions of the asphalt were cracked and broken;
- Two partially full approximately 275-gallon plastic totes of unknown content and several

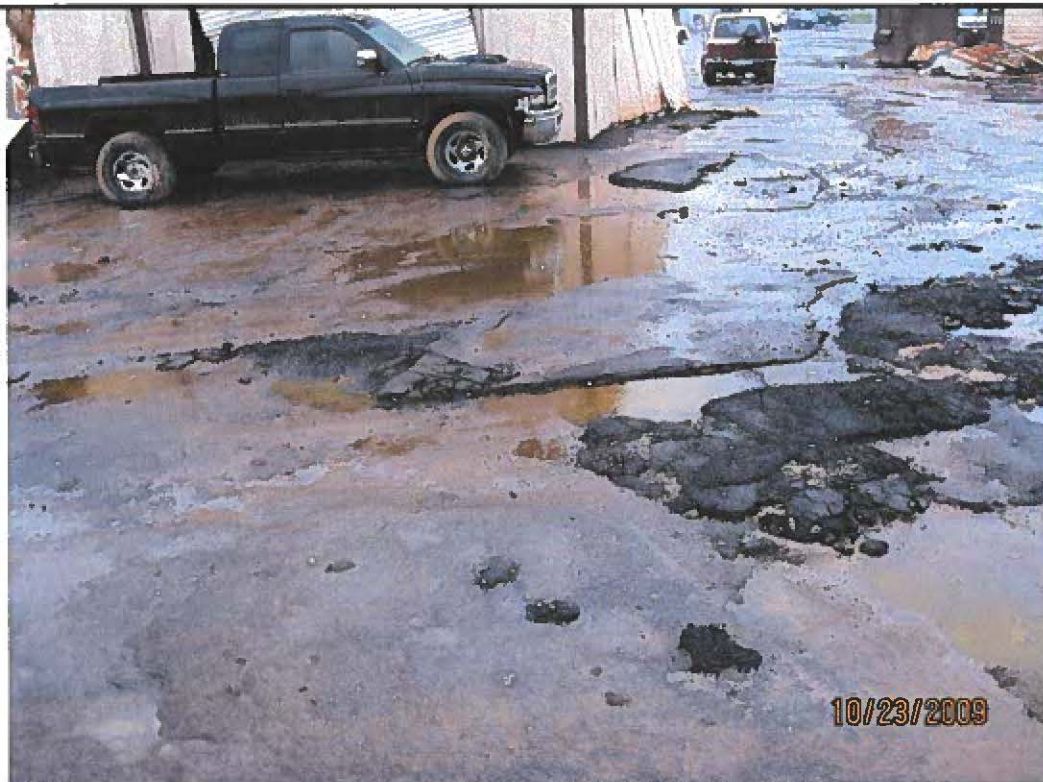
Facility Name: HW Enterprise Inc./Peach Chrome Plating	Location: Austell
Photo #: 10	Photographer: R. Hardy
Date: 10/23/2009	
Explanation: Tracking the release down gradient. Note cracks and breaks in asphalt.

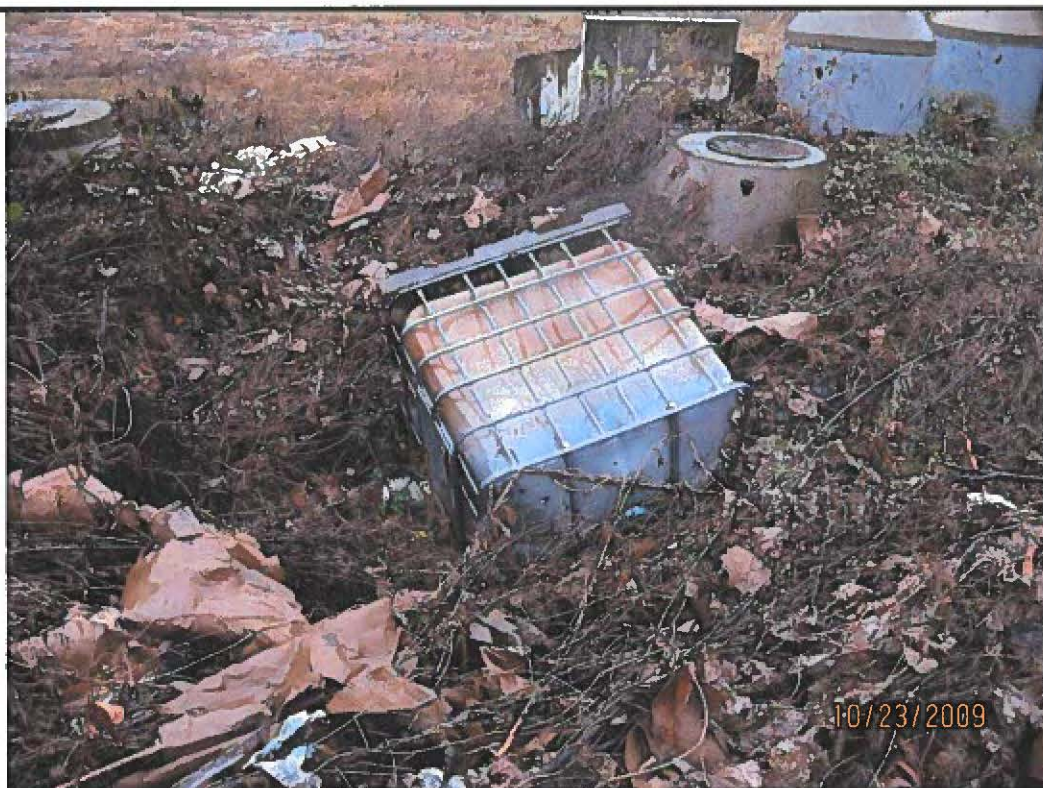
Explanation: Full 275 gallon tote in down gradient field.

other containers of varying sizes of unknown content and unknown volume were observed in a fielded area on the East Parcel;

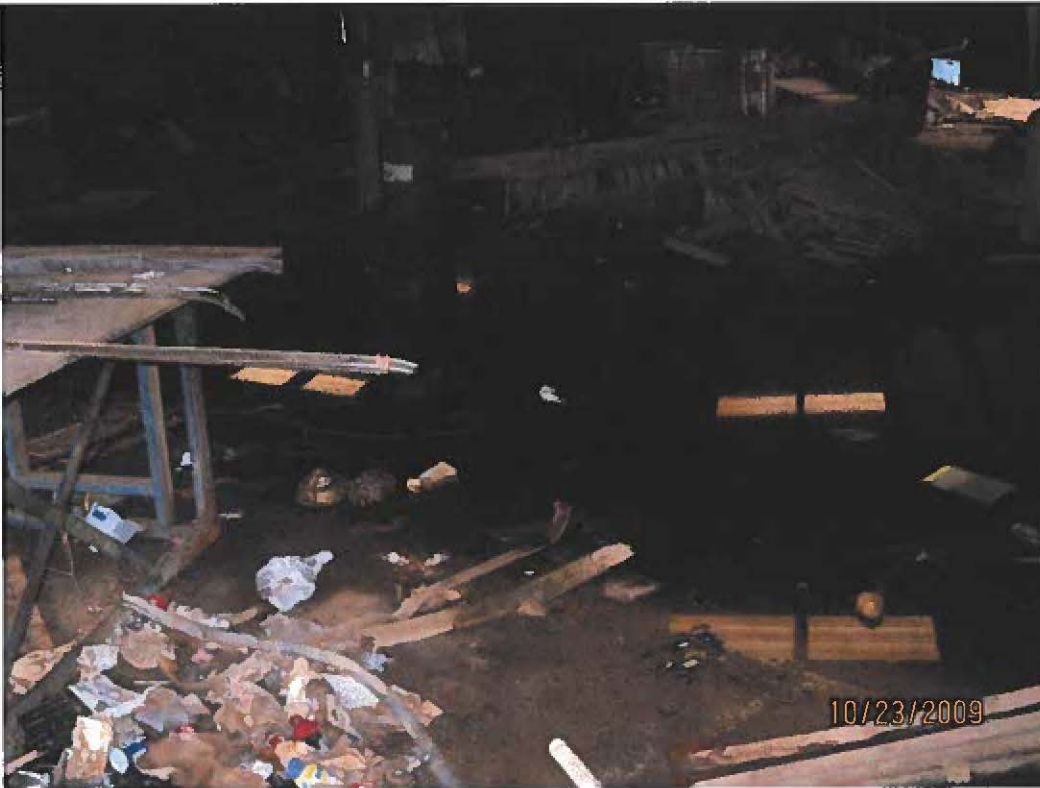
Photo #: 13	Photographer: R. Hardy	Date: 10/23/2009
--------------------	-------------------------------	-------------------------

Explanation: Southeast corner inside building
--

Upon entry to the building (the rollup door was open) it was noted that the pool of brown liquid outside originated inside and had accumulated in the southeast corner of the building (Photos 13, 14, 51, and 52). Much of the floor throughout the building was discolored and wet with dark brown to black liquid. Pathways of dark liquid on the floor were observed leading from the plating tank area near the west side of the building and from overturned drums in the northern portion of the building (Photos 15 and 20). EPD noted a ~one inch hose with one end laying inside the plating tank and the other end laying on the building floor. The tank was estimated to have a volume of approximately 600 gallons. The tank was mostly empty at the time of the inspection with a small amount of the dark brown liquid and assorted debris/sludge in the bottom below the opening in the hose. The hose was stained dark brown and was presumably used to siphon plating waste liquid from the plating tank (Photos 16, 17, 18, 19 and 20).

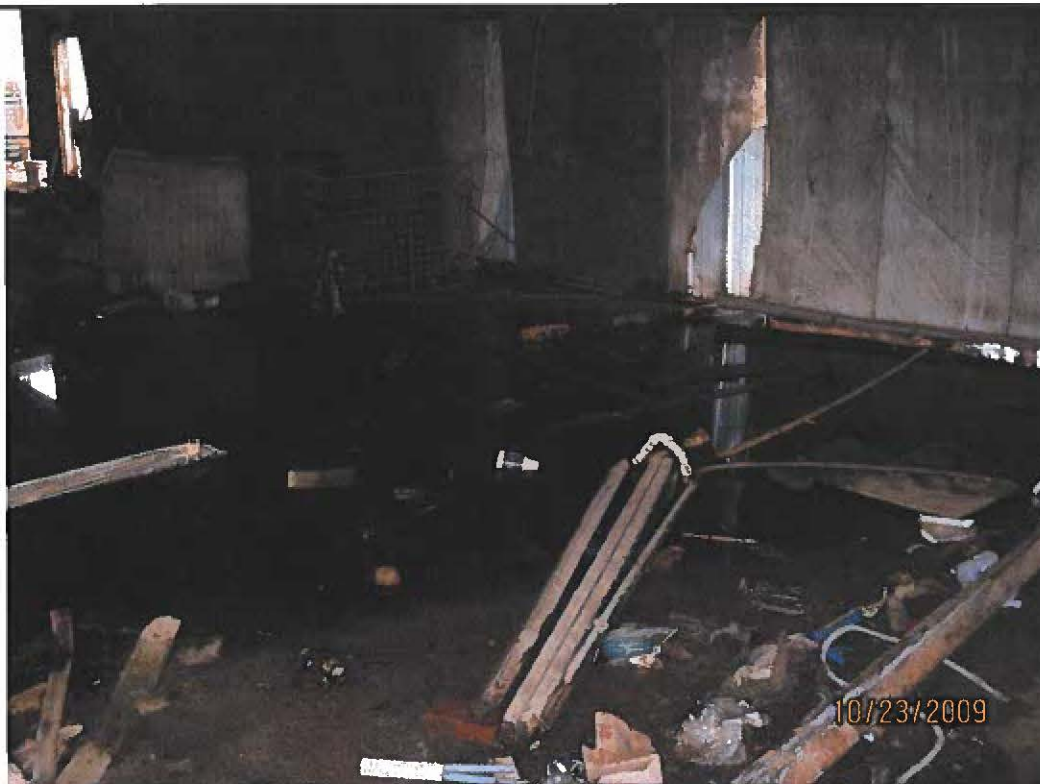
Photo #: 14	Photographer: R. Hardy	Date: 10/23/2009
--------------------	-------------------------------	-------------------------

Explanation: Southeast corner inside building. Note exit location of release photo right.
--

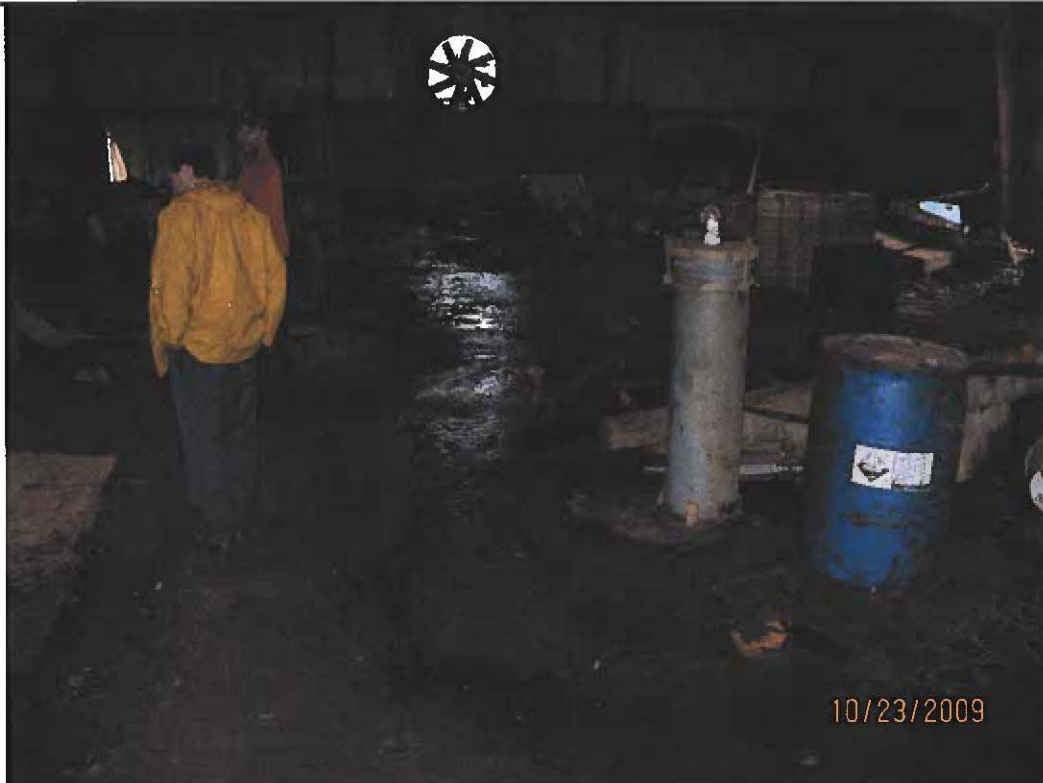
Facility Name: HW Enterprise Inc./Peach Chrome Plating	Location: Austell
Photo #: 15	Photographer: R. Hardy
Date: 10/23/2009	
Explanation: Inside building looking north. Note liquid on floor.

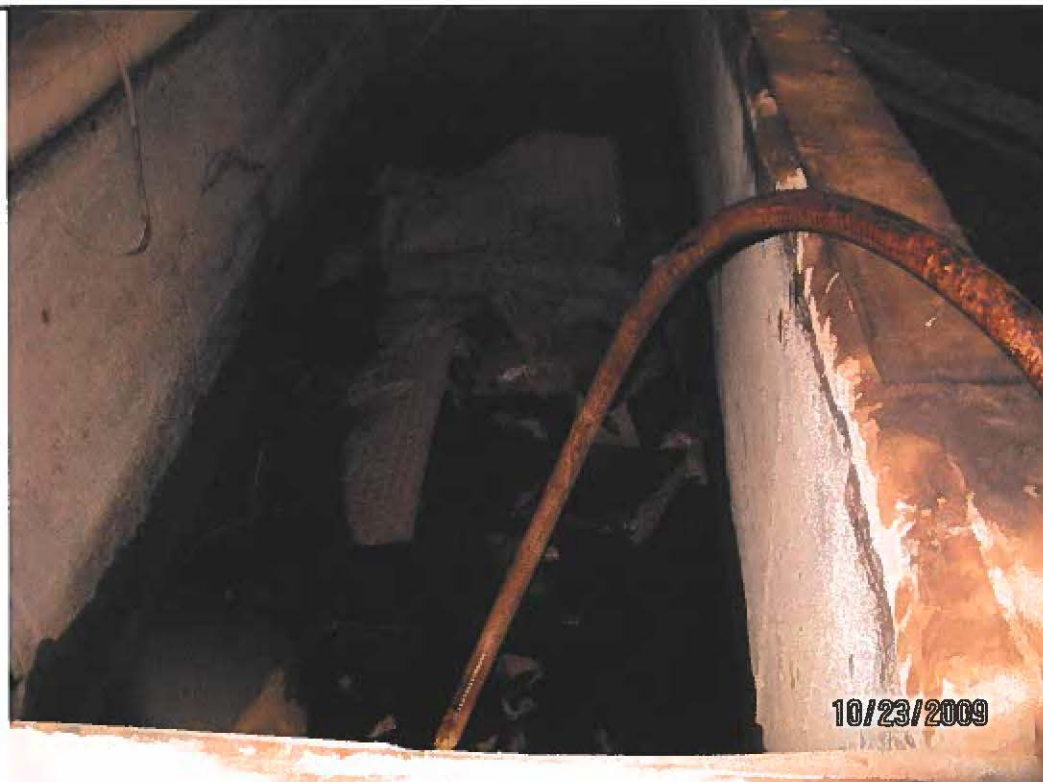
Facility Name: HW Enterprise Inc./Peach Chrome Plating	Location: Austell
Photo #: 16	Photographer: R. Hardy
Date: 10/23/2009	
Explanation: Plating tank with siphon hose

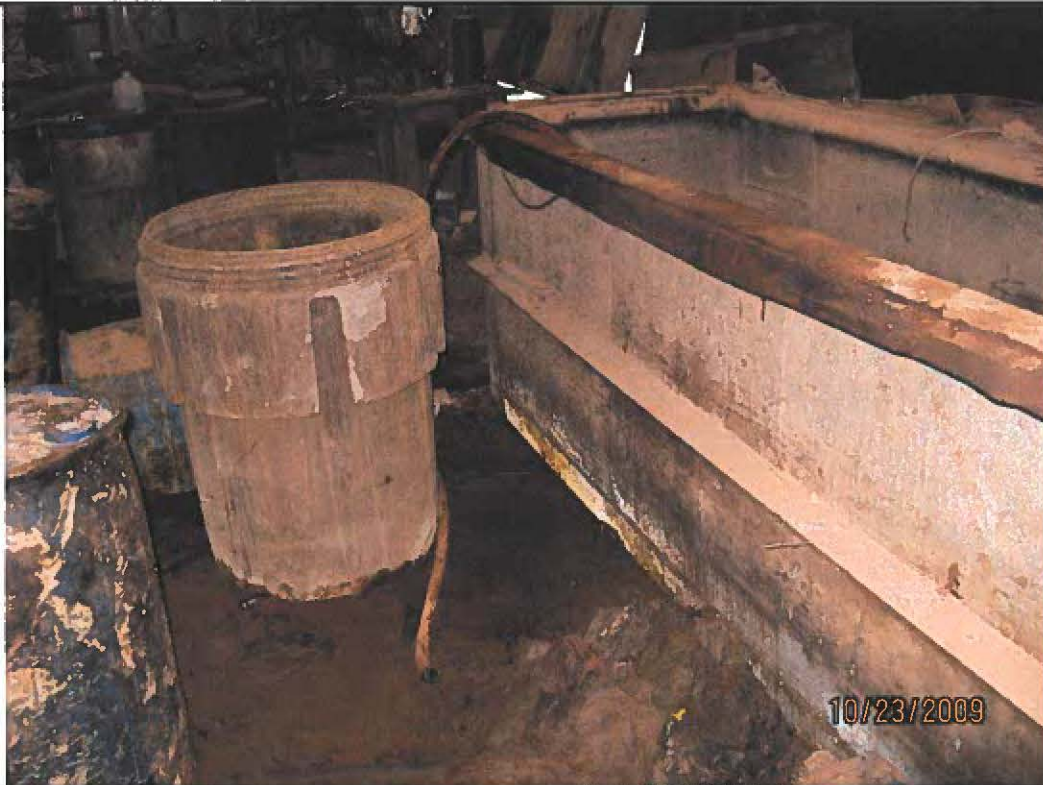
Facility Name: HW Enterprise Inc./Peach Chrome Plating	Location: Austell
Photo #: 17	Photographer: R. Hardy
Date: 10/23/2009	
Explanation: Plating tank with siphon hose.

- A one-inch hose with one end laying inside the plating tank and the other end laying on the building floor was observed. The volume of the tank was approximately 600 gallons and was mostly empty. Dark brown liquid and debris and sludge was observed in the bottom of the tank, below the opening of the hose. The hose was stained dark brown;

The USEPA START, the USEPA On-scene coordinator (OSC) and the USEPA Emergency and Rapid Response Services (ERRS) reported to the site on the evening of October 23, 2009 (Ref. 13). During the initial response, the USEPA documented chromic acid in the approximate 600-gallon plating tank in the electroplating building, multiple unlabeled drums and containers on the interior and exterior of the on-site buildings and liquids discharging from the buildings approaching Pond A and Sweetwater Creek. USEPA also noted the hose in the plating tank and that the hose may have been used to siphon the chromic acid onto the ground surface.

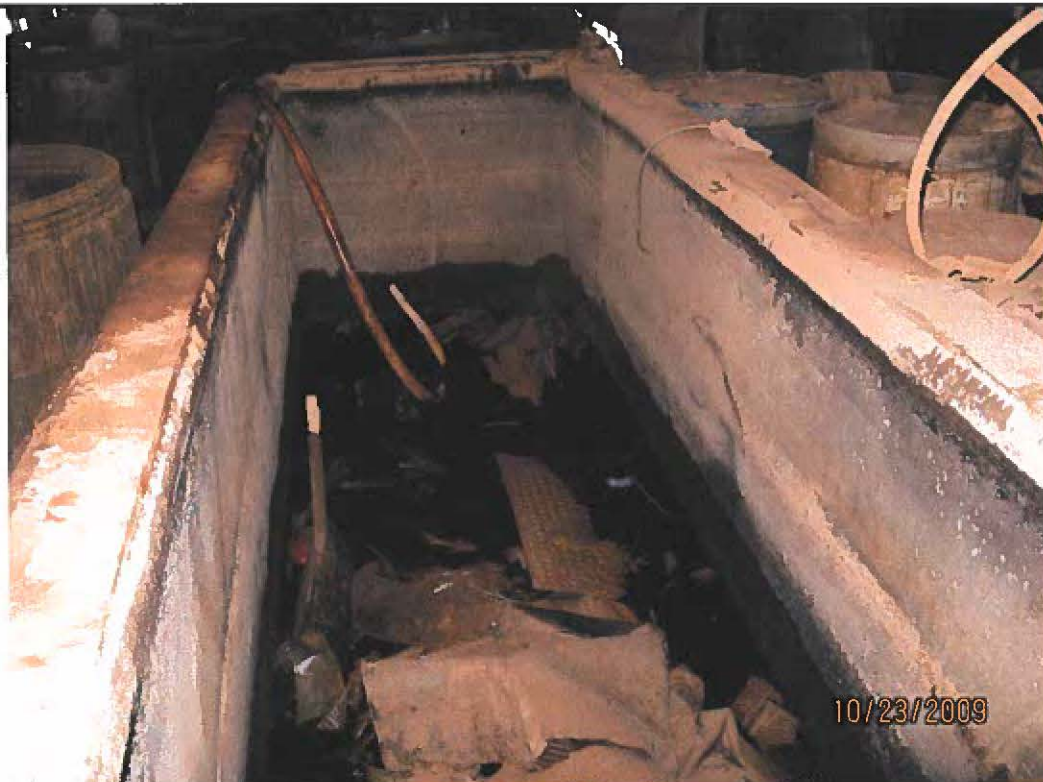
Facility Name: HW Enterprise Inc./Peach Chrome Plating	Location: Austell
Photo #: 18	Photographer: R. Hardy
Date: 10/23/2009	
Explanation: Plating tank with siphon hose.

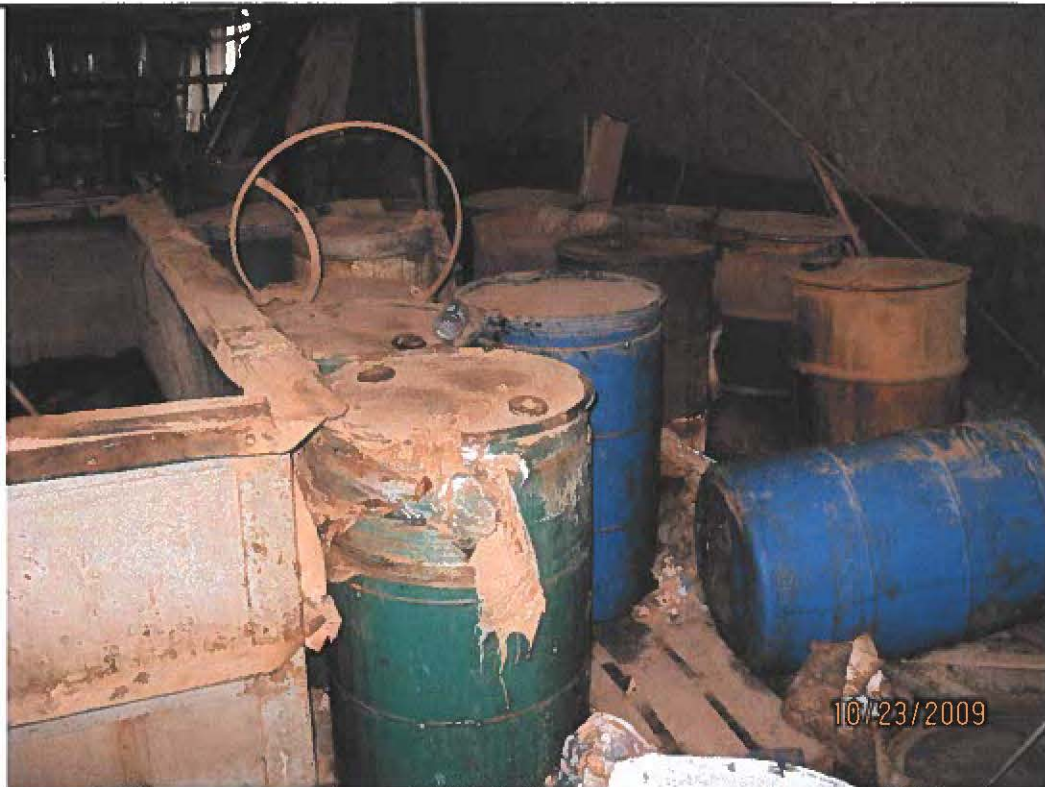
Facility Name: HW Enterprise Inc./Peach Chrome Plating	Location: Austell
Photo #: 19	Photographer: R. Hardy
Date: 10/23/2009	
Explanation: Containers full of waste sludge

- Sixteen partially full 55-gallon unlabeled containers were observed full of a material similar in appearance to waste sludge near the plating area, on the western side of the electroplating building. Six additional partially full 55-gallon containers were observed in the northwest corner of the electroplating building. The labels on the 55-gallon containers were damaged; however, one label was legible and read "Caustic Soda Anhydrous." One additional partially full 55-gallon container was observed open, laying on its side, with metallic material extending from the drum onto the building floor;

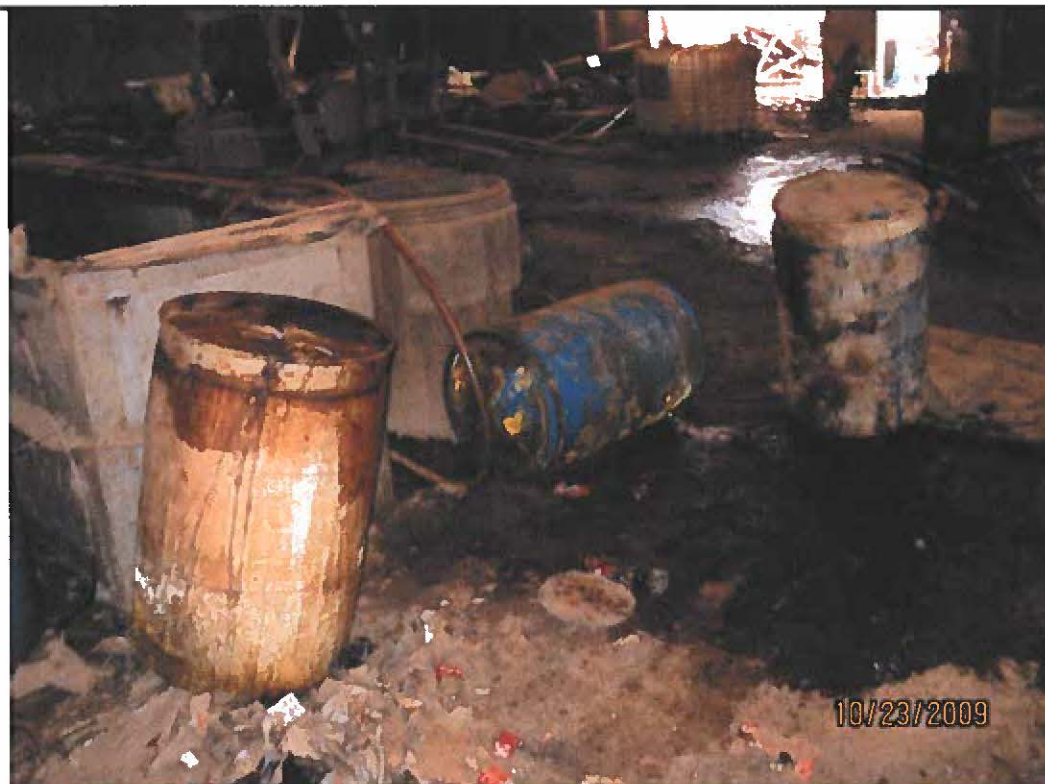
Facility Name: HW Enterprise Inc./Peach Chrome Plating	Location: Austell
Photo #: 20	Photographer: R. Hardy
Date: 10/23/2009	
Explanation: Plating tank with siphon hose. Note stain on floor

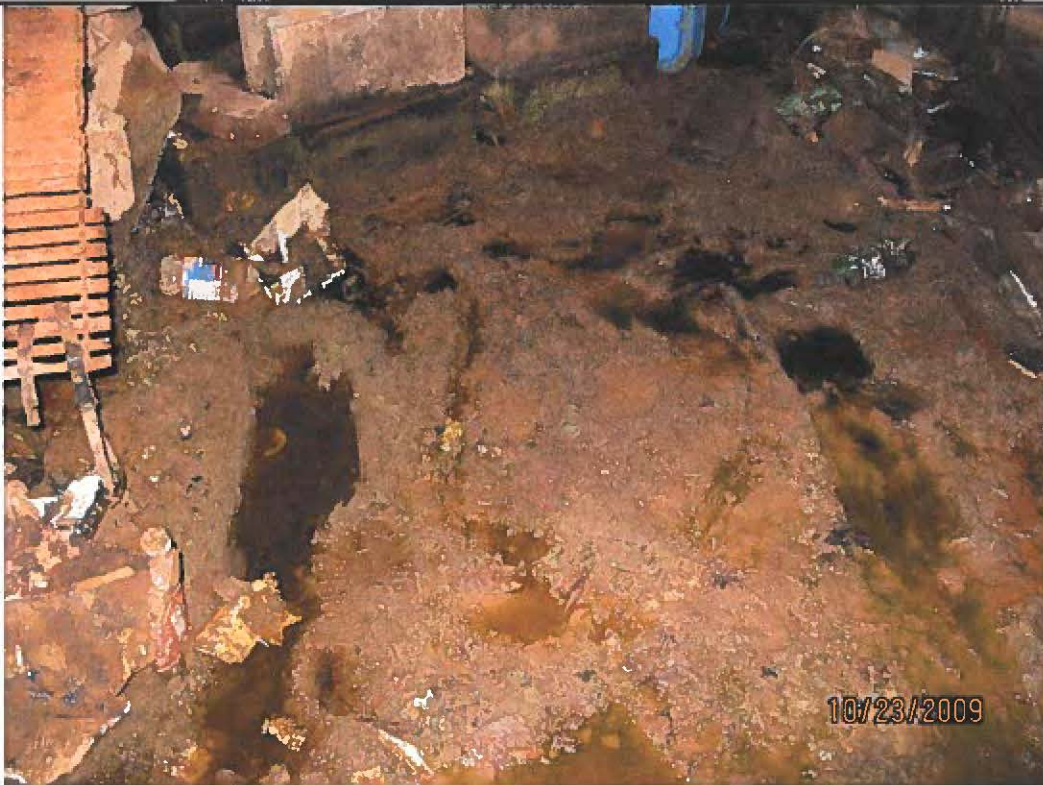
Facility Name: HW Enterprise Inc./Peach Chrome Plating	Location: Austell
Photo #: 23	Photographer: R. Hardy
Date: 10/23/2009	
Explanation: Puddles of dark brown liquid on soil inside building.

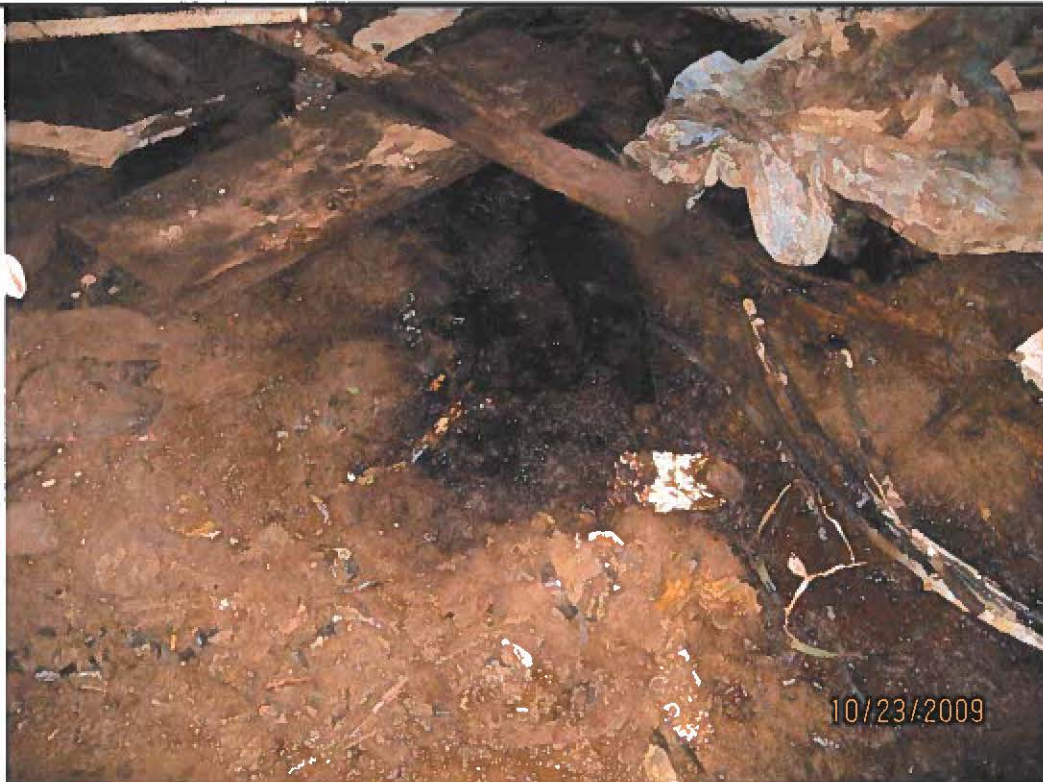
Facility Name: HW Enterprise Inc./Peach Chrome Plating	Location: Austell
Photo #: 24	Photographer: R. Hardy
Date: 10/23/2009	
Explanation: Puddles of dark brown liquid on soil inside building.

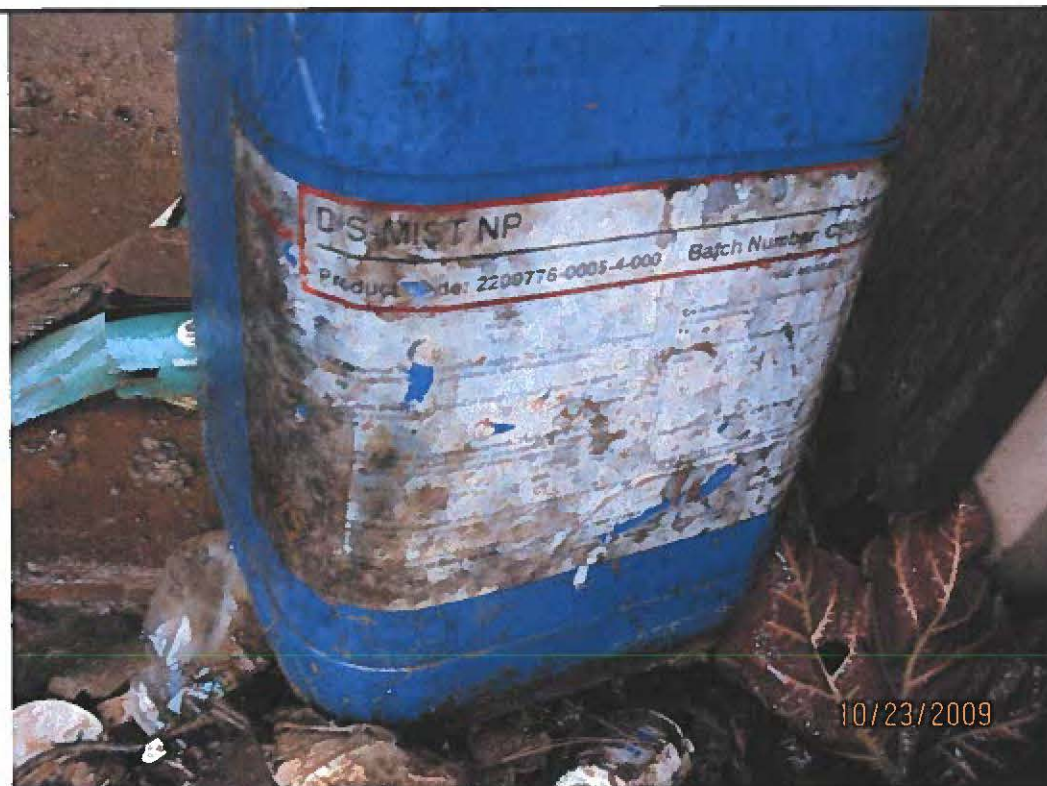
Facility Name: HW Enterprise Inc./Peach Chrome Plating	Location: Austell
Photo #: 26	Photographer: R. Hardy
Date: 10/23/2009	
Explanation: DIS MIST NP

additives were scattered throughout the building. Among those with legible labels included: "Cupra Brite 432 Replenisher (2)"; "DIS-MIST" (2); "Reflecta Maintenance-Nickel Plating Agent" (2). (Photos 25, 26, 45, and 46. Outside a tear in the north building wall, pushed through the wall by flood waters, were two 5 gallon containers of Nickel sulfate liquid (Photos 47,48). Two unlabeled 275 gallon totes full of brown liquid were also observed inside the building (Photo 50).

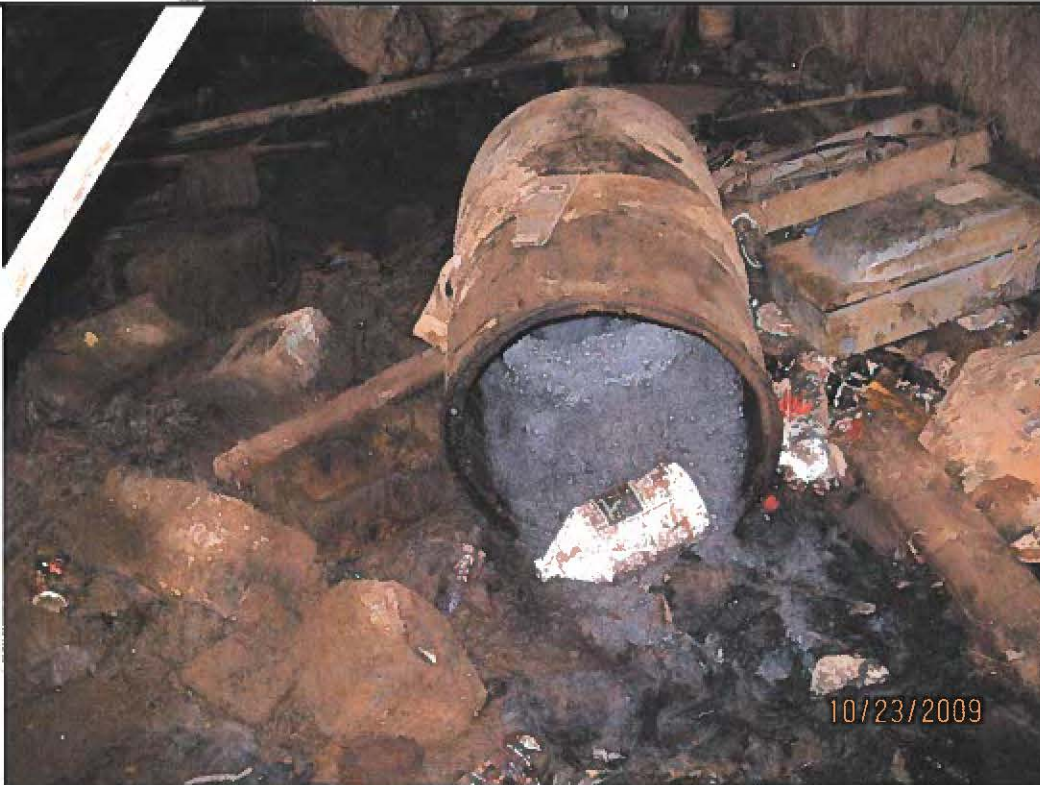
Explanation: Drum spilling metallic material inside building.

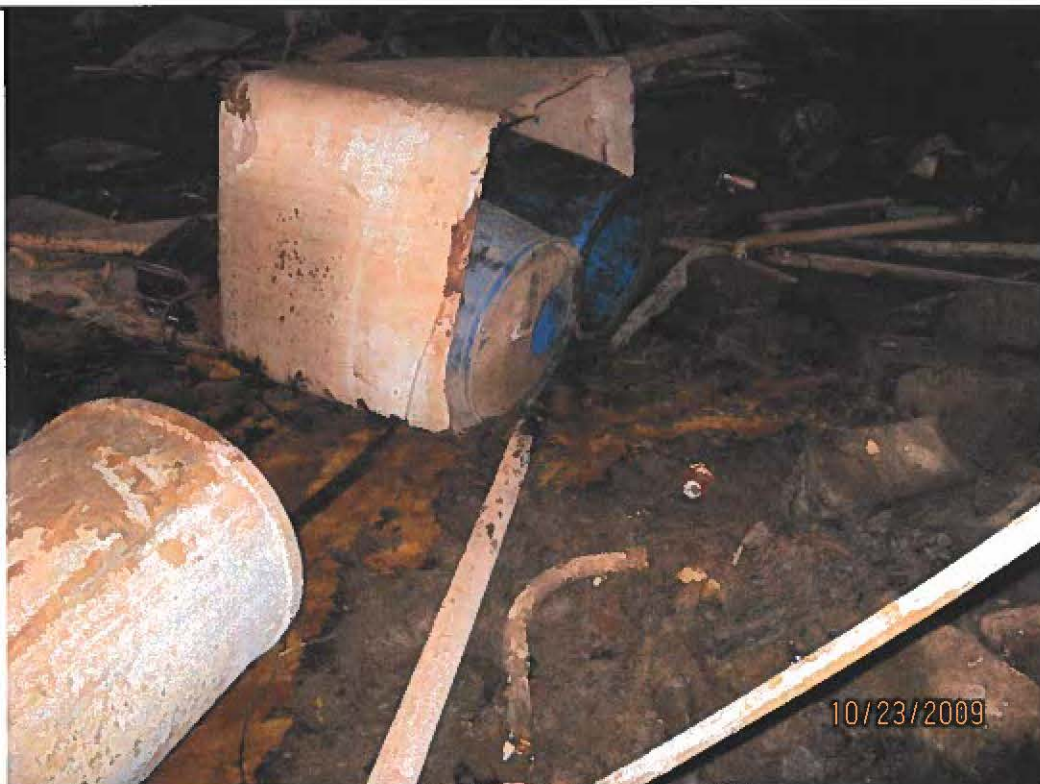
Explanation: Empty drums with pooled dark brown liquid. North end of building
